Transport
Canada

TP 185E
Issue 4/2006

AVIATION SAFETY LETTER

Recently Released TSB Reports

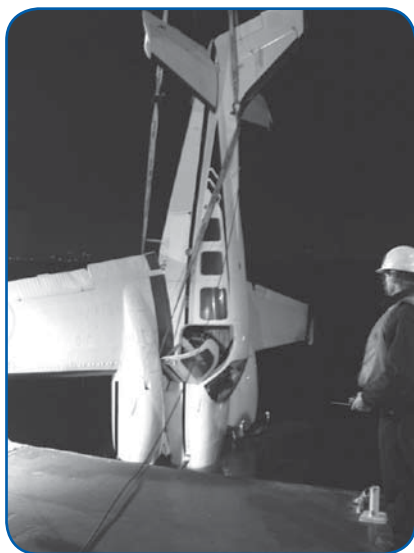
Recovery operation of the aircraft

below the minimum descent altitude (MDA) and continued a controlled descent in instrument meteorological conditions (IMC) until the aircraft struck the water.

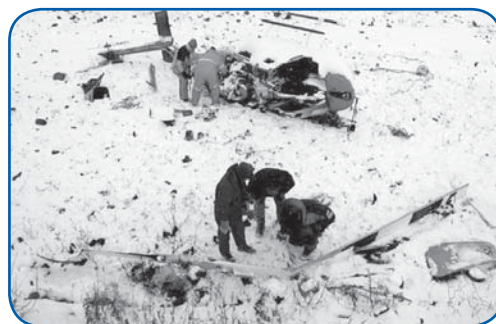
Accident investigators examine the scene of the accident

Damage to the rotor drive system and the mast indicated low or no power being transmitted from the engine at impact, although the throttle was fully open, and the engine was operating. The amount of fuel on board prior to the occurrence could not be determined. However, the quantity had been planned to be near the minimums required by regulations. Fuel consumption would have been considerably higher at the higher power requirements during slinging operations, and the reserve quantity may have been less than originally planned. An additional shuttle of a load of hydraulic components would have further reduced the reserve fuel quantity by at least 2.0 gal. The pilot had abruptly departed for the refuelling site, which may suggest a low fuel state.

A momentary power interruption at a crucial moment may have distracted the pilot, and caused the helicopter to overshoot the intended touchdown area and continue laterally onto the fuel drum. The pilot was wearing his helmet; however, the severity of the impact caused the helmet to fail around the side where the shell had been cut away to accommodate the headphone earpiece. A full-shell helmet, which has the earpiece inside the shell, would have been structurally stronger and afforded better protection.

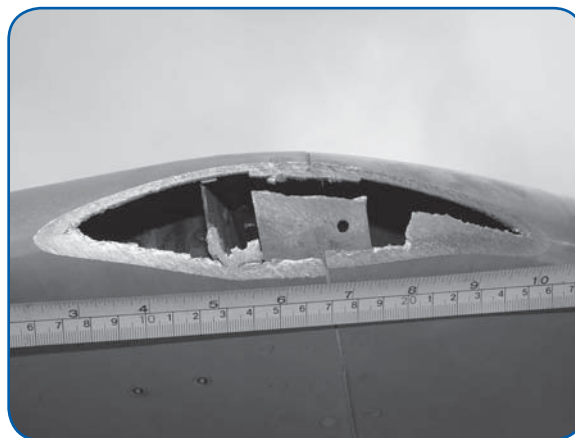
On May 28, 2004, a Boeing 727-225 freighter was on a night cargo flight from Hamilton, Ontario, to Moncton, New Brunswick. The first officer was performing the pilot flying (PF) duties, and the captain was conducting a line check on the first officer. The en route portion of the flight to Moncton was uneventful. On arrival at Moncton, the flight crew conducted two unsuccessful approaches in darkness and poor weather conditions before landing on the third approach. A post-flight inspection of the aircraft in Moncton found visible damage on the left wing. The tip of the left outboard leading edge flap and the outboard trailing edge flap “canoe” were abraded. The damage was

consistent with a slight contact with the runway. Available information indicates that the wing scrape occurred at 02:41 Atlantic Daylight Time during the rejected landing after the second approach. The aircraft was at a pitch angle of 5° nose up, 14° of left bank, and a derived aircraft height above ground of approximately 26 ft. There were no injuries.

Close-up photograph of left outboard leading edge flap damage

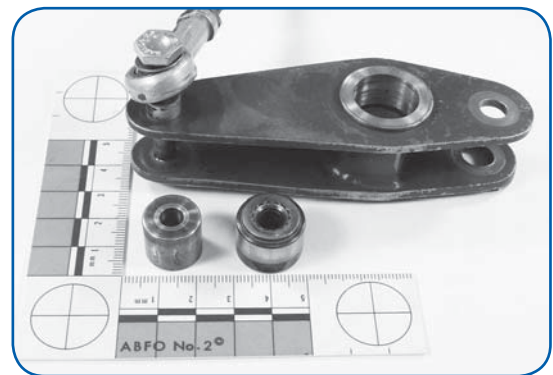
Bellcrank assembly with a part number 5453032-1 roller on the left and a YCRS-12 bearing on the right

1. An incorrect roller of a smaller diameter and type was installed on the left main landing gear outboard bellcrank assembly, contrary to company and industry practice.
2. The smaller diameter roller reduced the required rigging tolerances for the bellcrank-to-cam assembly in the down-and-locked position, and allowed the roller to eventually move beyond the cam cutout position, resulting in the collapse of the left landing gear.
3. A rigging check was not carried out after the replacement of the bellcrank roller. Such a check should have revealed that neither the inboard nor outboard bellcrank assembly met the minimum rigging requirements for proper engagement with the positioning cam.

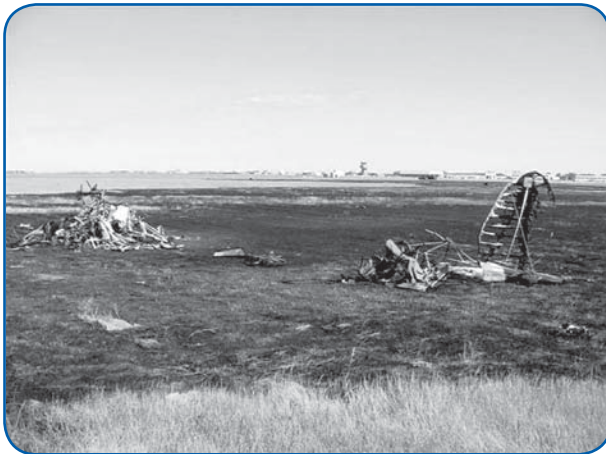
The Dairy Turn is a scripted manoeuvre, with the intention to create the illusion of a close call as two of the three aircraft cross near show centre, also involving the jet-powered truck for visual effect. Other display team members understood that the contract for safe separation required the pilots to establish visual contact with each other at specific location of the manoeuvre and maintain separation visually. One of the aircraft had been late on its track on occasions since the display had been developed. This lateness had not previously caused any difficulties for the performers. The manoeuvre had been recently modified. Whether the contract for safe separation was also revised could not be established.

Charred remnants of the air demonstration aircraft

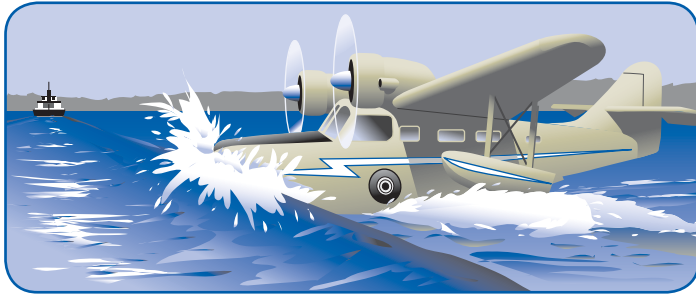
— On March 24, 2006, a **Grumman Goose G-21A** was damaged on landing in Hardy Bay, Port Hardy, B.C. The aircraft had landed in a large bow wake created by a boat. The operator grounded the aircraft after maintenance identified upper wrinkles in the skin above the front windows and bent engine mounts. *TSB Report A06P0044.*

Artist's impression of aircraft landing on bow wake

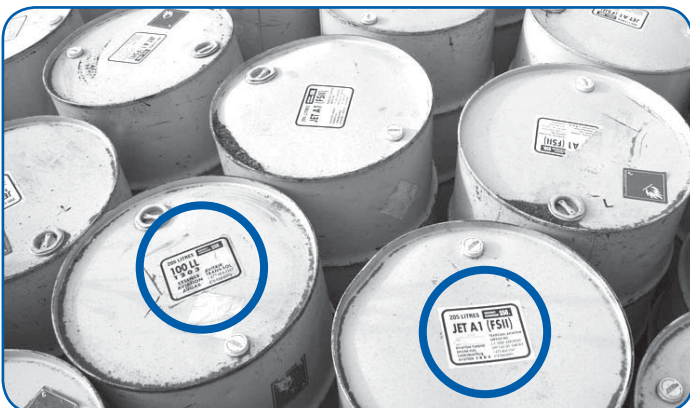
The on-going investigation into this occurrence revealed that the wholesaler had mistakenly delivered four barrels of Avgas and 36 barrels of Jet A fuel, instead of 40 barrels of Jet A fuel. It also revealed that workers loading the product on the truck at the wholesaler’s yard and those delivering the product to SOPFEU had mistakenly identified the product. The pilots using the product did not correctly identify it before fuelling. Two of the four helicopter operators working from the staging area mistakenly fuelled their aircraft with Avgas.

Photo 1: View of fuel barrels at base camp

The barrels delivered were all white, and all identifying stickers were also white. The identifying stickers included all the necessary information, as specified by provincial

regulations. The only difference between the two products was the words “100LL Avgas” and “Jet A fuel.” (See photos 1 and 2 taken on site.)

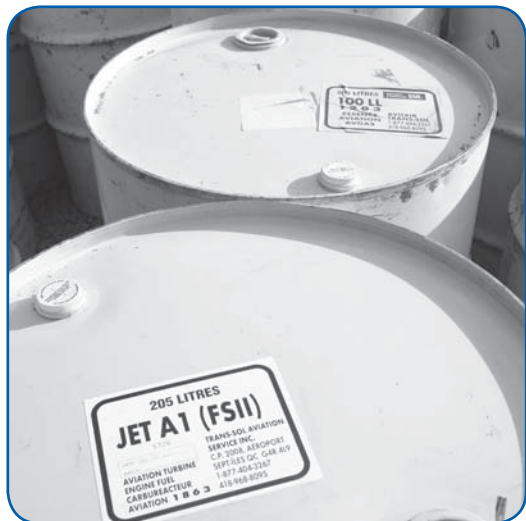
Photo 2: View of fuel barrel labels

The wholesaler need only ensure that the petrol product they deliver meets provincial regulations, i.e. the container must be cleaned, filled, and sealed on site; and identifying stickers affixed on the container must include the date, the type of product, batch number, and dangerous goods information.

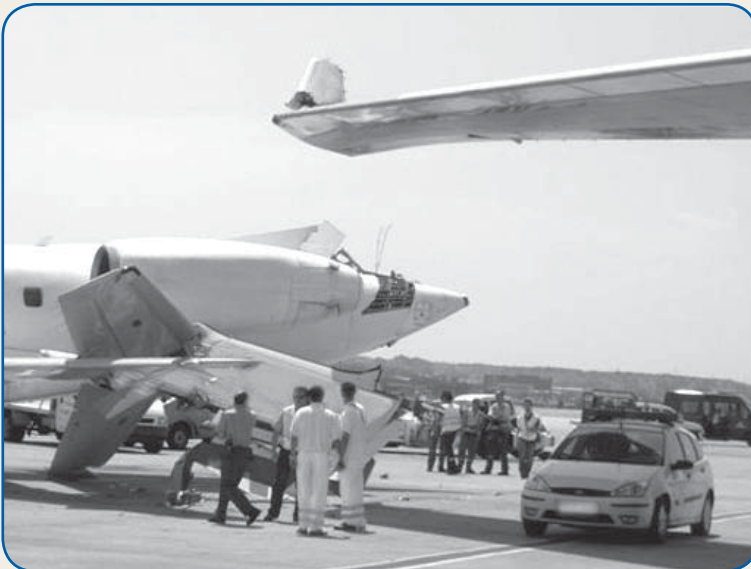
The photo on the left shows the result of a spectacular ground collision on July 15, 2006 in Madrid, Spain. The wingtip of a taxiing Boeing 747-400 sliced clean the T-tail of a stationary Embraer 145 jet. Fortunately there were no injuries, but there was significant stress for all involved.

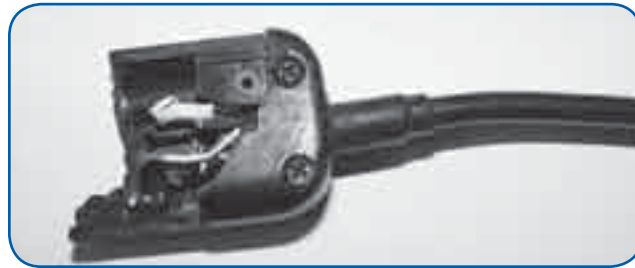
On December 7, 2005, an MBB-BO105 helicopter was operating near Marystown, N.L. The helicopter was observed flying along the shoreline, at low altitude, in snow, and in darkening conditions. The helicopter struck the water about 1 000 ft from shore, and sank to the bottom of Mortier Bay. The pilot and passenger escaped from the helicopter; however, they later perished in the frigid water. The TSB investigation into this accident (A05A0155) is ongoing. After the accident, an examination of the pilot's aviation helmet found that the end fitting of the communication cord was fractured at the point where it attaches to the helicopter (see Figure 1).

Figure 1. Fractured cord end fitting

The communication cords for front-seat occupants connect to receptacles located on the overhead center console. When the helicopter was recovered, the metal pins from the end fitting were still inside the receptacle. Metal remnants from the connection show that the cord was being pulled sideways, towards the pilot's door, when the fracture occurred. A downward pull is required to release the connection. A break test of a similar fitting required a 70-lb pull before the cord failed. After ditching or water impact, the occupants of a capsized helicopter are prone to disorientation. Therefore, unimpeded egress through any available exit is vital to survival. An attached communication cord that will not release cleanly may impede this egress.

Other operators may have aircraft with similar direct-to-airframe connections, and may be unaware that these can impede egress in an emergency. Therefore, Transport Canada may wish to advise the aviation community that these connection types may impede egress, and that an intermediate cord can help to mitigate this hazard.

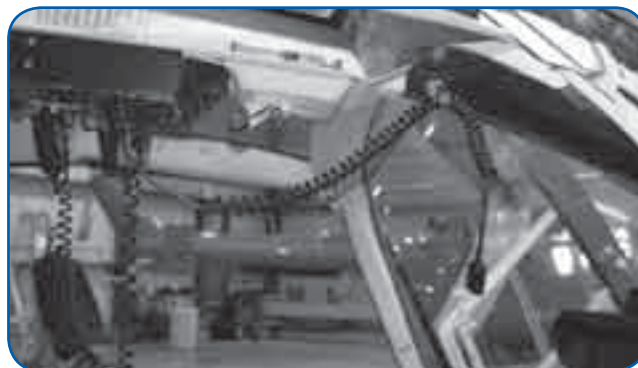
In the past, similar BO-105 helicopters have been fitted with an intermediate “pig-tail” communication cord for helmet connections. Instead of plugging the helmet cord into the helicopter's receptacle, the helmet cord is instead plugged into this intermediate cord (see Figure 2).

Figure 2. Intermediate helmet “pig tail” connection cords

The helmet connection plug can release cleanly from the intermediate “pig-tail” cord receptacle as it is pulled in the direction of travel during egress. Over a period of years, the use of the intermediate helmet cords at this operator declined, perhaps because pilots were not aware that the cords ensure separation in an emergency. However, since this accident, the operator has indicated that the use of intermediate “pig-tail” cords for helmet connections will now be re-instituted where necessary.
